# Manhole Inspection Summary

Manhole # S23I\_\_039MH

Insp Date: **6/4/08 10:36 AM**

**Location** Address: **1525 Lemmon ST**

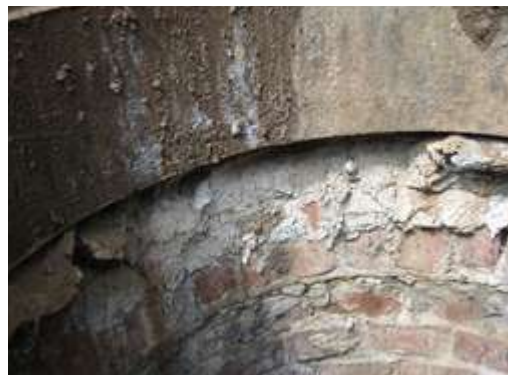
Defect 3

Condition: ☐ Sound ☒ **Cracked** ☐ Root Intrusion ☒ **Loose Brick** ☒ **Deteriorated**

Infiltration: ☐ None ☒ **Joint** ☐ Cracks ☐ Mortar ☐ Roots ☐ Wall

Cracks, loose bricks and deterioration in chimney

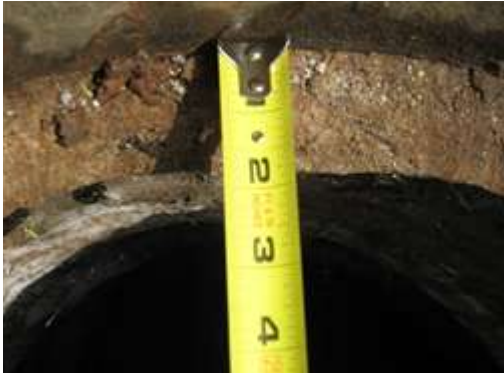
Defect 4

**Frame** Offset: **1.** (in.) Condition: ☒ Sound ☐ Cracked ☐ Leaks  
**75**

Frame Offset 1.75"

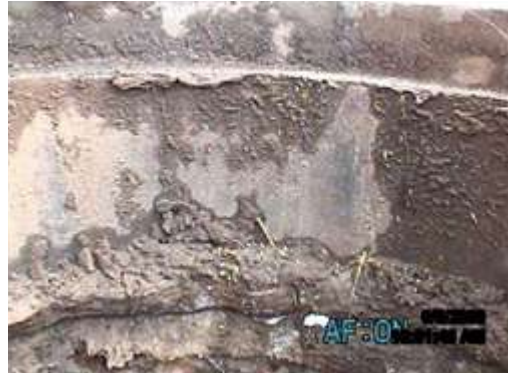
Defect 2

infiltration at chimney frame-lid

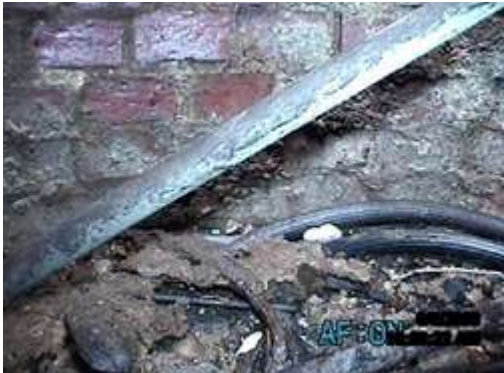
Defect 1

Condition: ☐ Sound ☐ Cracked ☐ Root Intrusion ☐ Deteriorated ☐ Leaks ☒ **Debris**

debris on bench

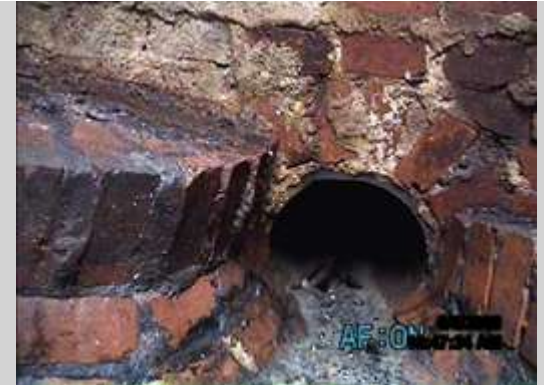
12 O'Clock Outflow

8 in. Circular Gravity Sewer  
Pipe Out @ 12 O'Clock

Pipe Height: **8.4** (in.) Rod and Bar (Angled)  
Pipe Material: **Clay** ☐ Pipe Lined  
Invert Depth: **8.49** (ft.) Flow Characteristics: **Slow**  
Deposits: ☒ None ☐ Mud ☐ Sludge ☐ Debris ☐ Grease  
Silt Depth: **0** (in.) Deposits Extent:  
Infiltration: **None** Pipe Seal Cond: **Sound**

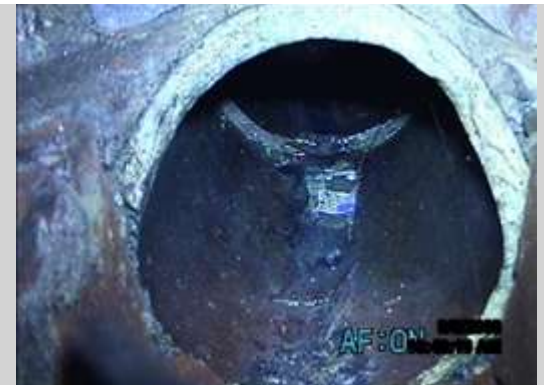
3 O'Clock Inflow

6 in. Circular Gravity Sewer  
Pipe In @ 3 O'Clock

Pipe Height: **6** (in.) Rod and Bar (Angled)  
Pipe Material: **Clay** ☐ Pipe Lined  
Invert Depth: **7.61** (ft.) Flow Characteristics: **Slow**  
Deposits: ☒ None ☐ Mud ☐ Sludge ☐ Debris ☐ Grease  
Silt Depth: **0** (in.) Deposits Extent:  
Infiltration: **None** Pipe Seal Cond: **Sound**

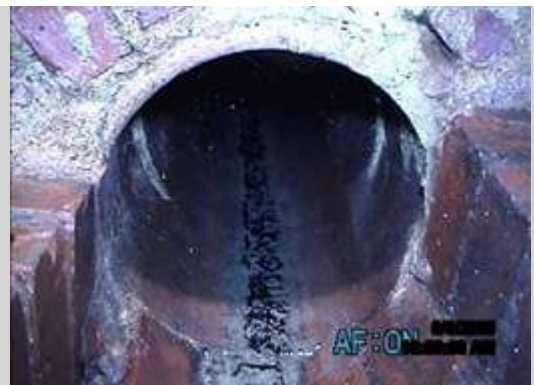
9 O'Clock Inflow

8 in. Circular Gravity Sewer

Pipe Height: **8.4** (in.) Rod and Bar (Angled)

Infiltration: **None** Pipe Seal Cond: **Sound**
